Patient details

Implant details

Acetabular cup

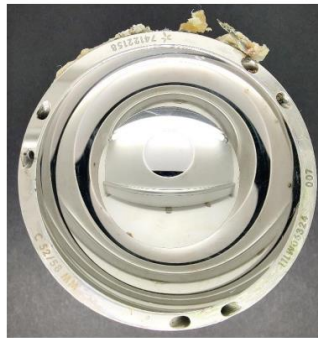
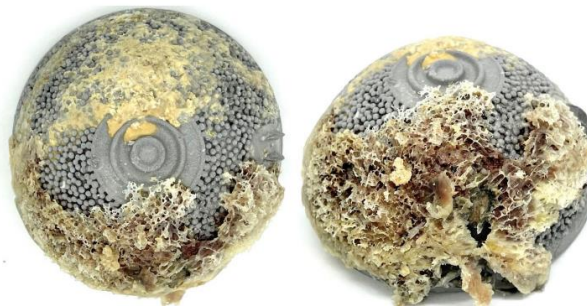
There were scattered, multidirectional scratches over most of the bearing surface. Using the Smith & Nephew logo to reference the 12 o'clock position, there was thinning of the rim extending from the 2 to 6 o'clock position, with discolouration of the flat surface. On the posterior surface there was significant bony ingrowth with signs of metal staining.

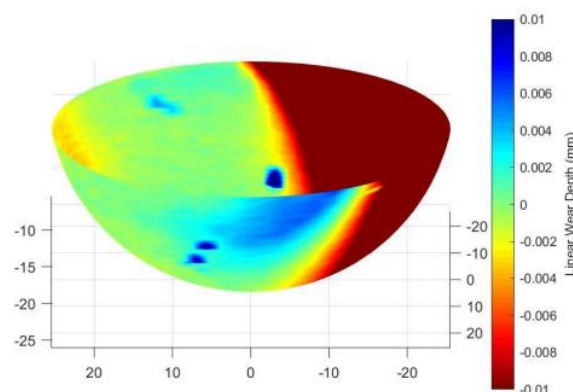
Acetabular cup

Coordinate Measuring Machine (CMM) analysis. The superoanterior rim is to the right on the wear map.

Max Linear Wear (μm)	Volumetric Wear (mm^3)	Nominal Diameter (mm)
Acetabular Cup	132	48.16	52.0286

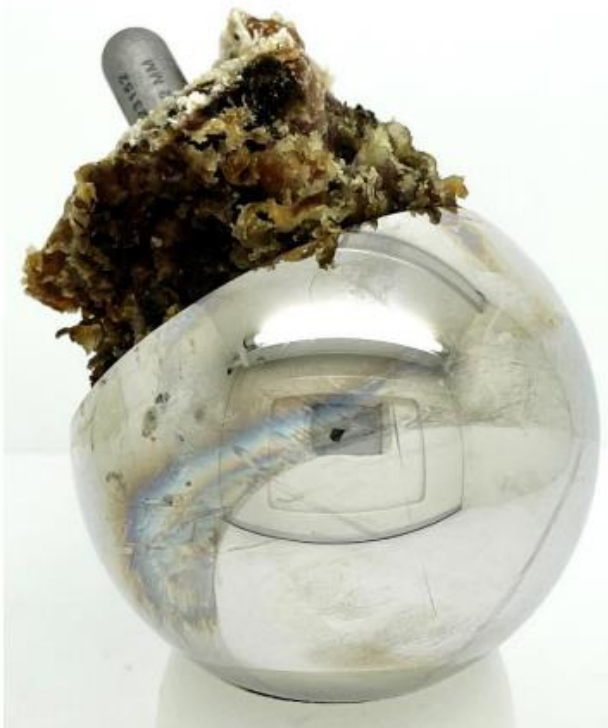
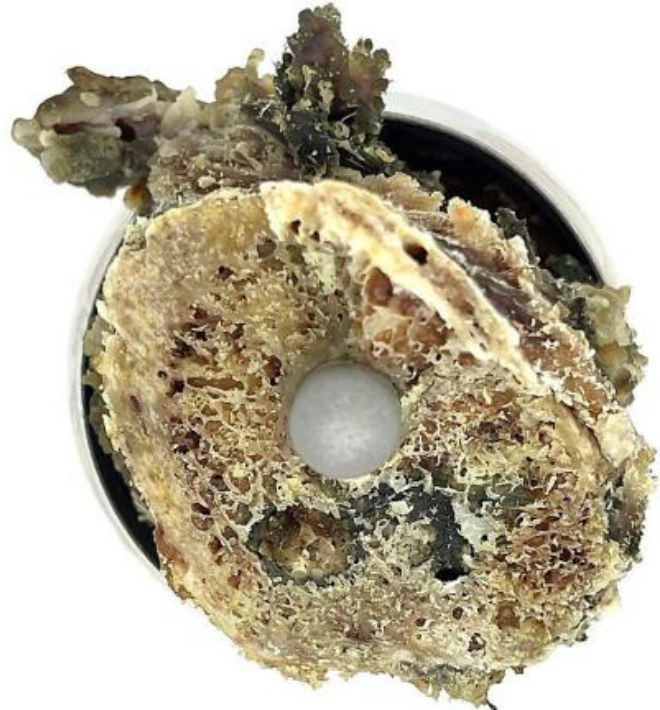
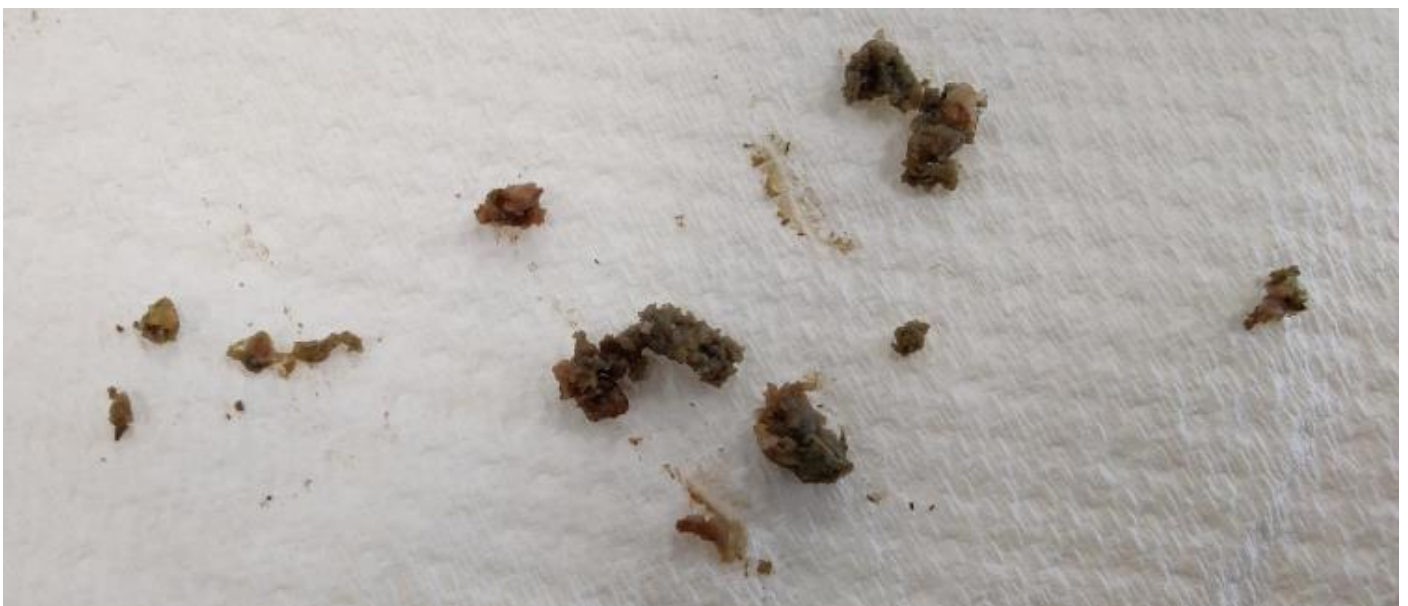
Femoral head

A prominent broad wear scar was visible with an obvious iridescent boundary. There was black discolouration of the bone surrounding the femoral peg. Retrieval damage was also identified on the bearing surface in the form of isolated scratches. See additional figures on the next page showing bone degradation and debris removal.

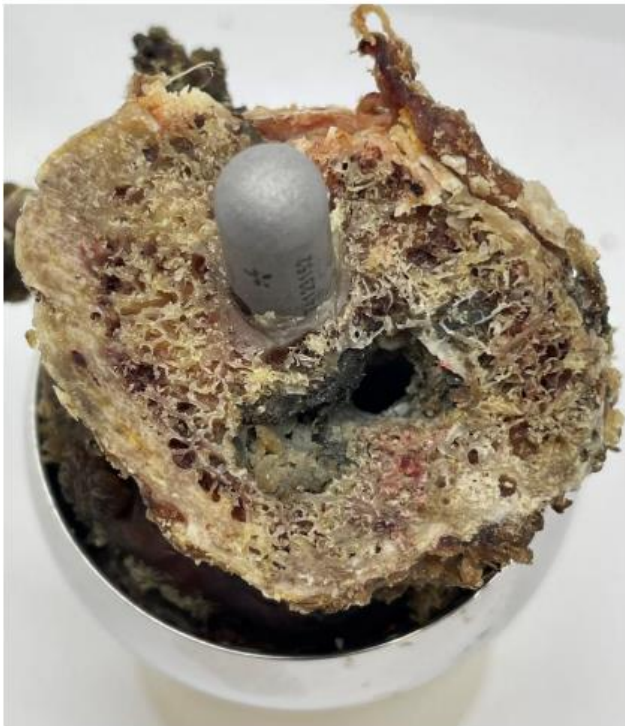
Probing of the femoral bone revealed large cyst, over 10mm in depth to the prosthetic surface. The cyst was filled with necrotic, metal stained bone debris (above). Image below taken following removal of necrotic material.

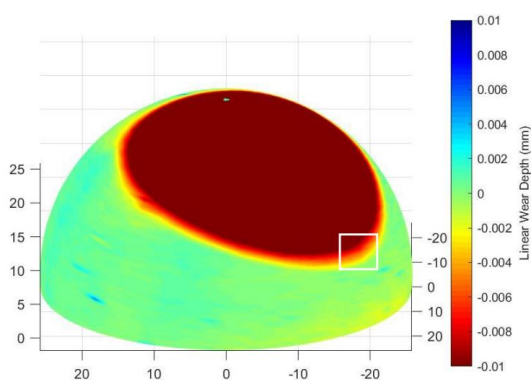
Femoral head

The apex of the wear scar (white box) is in the superoanterior region.

Max Linear Wear (μm)	Volumetric Wear (mm^3)	Nominal Diameter (mm)
Femoral Head	54	31.22	51.7684

The diametrical clearance was calculated to be 260.2 microns.

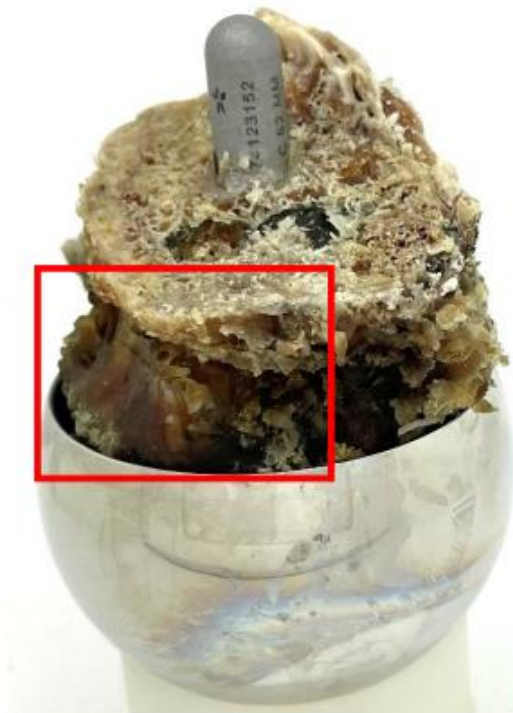
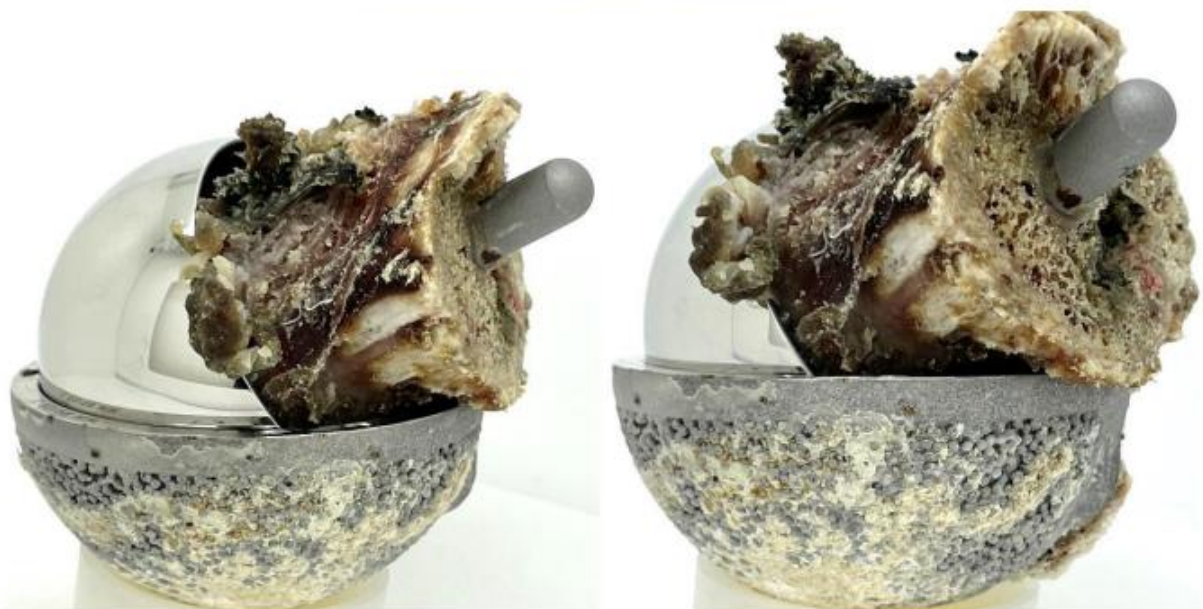
Additional findings

There was scalloping of the posterior femoral neck consistent with femoroacetabular impingement (as shown by the red rectangle) in extension/external rotation.

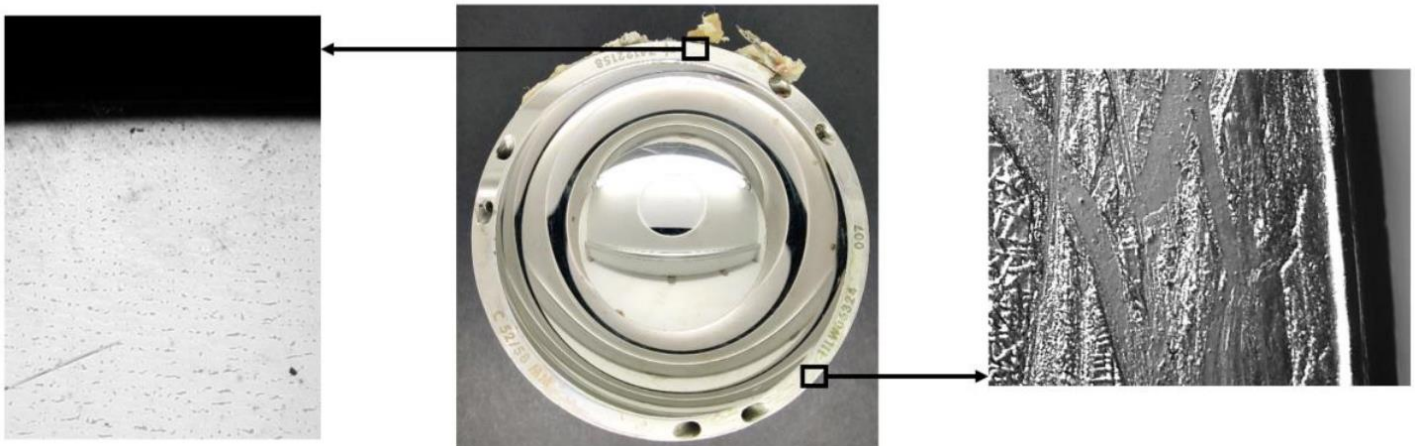
The total wear of the bearing surfaces was over 79 mm³, meaning that the device wore at a mean rate of approximately 8mm³ per year.

Successfully functioning MoM devices wear at less than 1 mm³/year. The increase in wear occurred due to posterior impingement of the femoral neck on the rim of the cup leading to anterior subluxation of the femoral head. The effects of this anterior subluxation on the rim can clearly be seen in the images below, with gross surface disruption over the anterior rim (right) compared to as manufactured surface (left).
