Implant details

Reason for revision as listed by the surgeon: Aseptic loosening of socket and adverse soft tissue reaction to particulate debris

Explanted prosthesis: 32 mm Biolox delta ceramic head (-3 offset) and liner, and Ti alloy shell

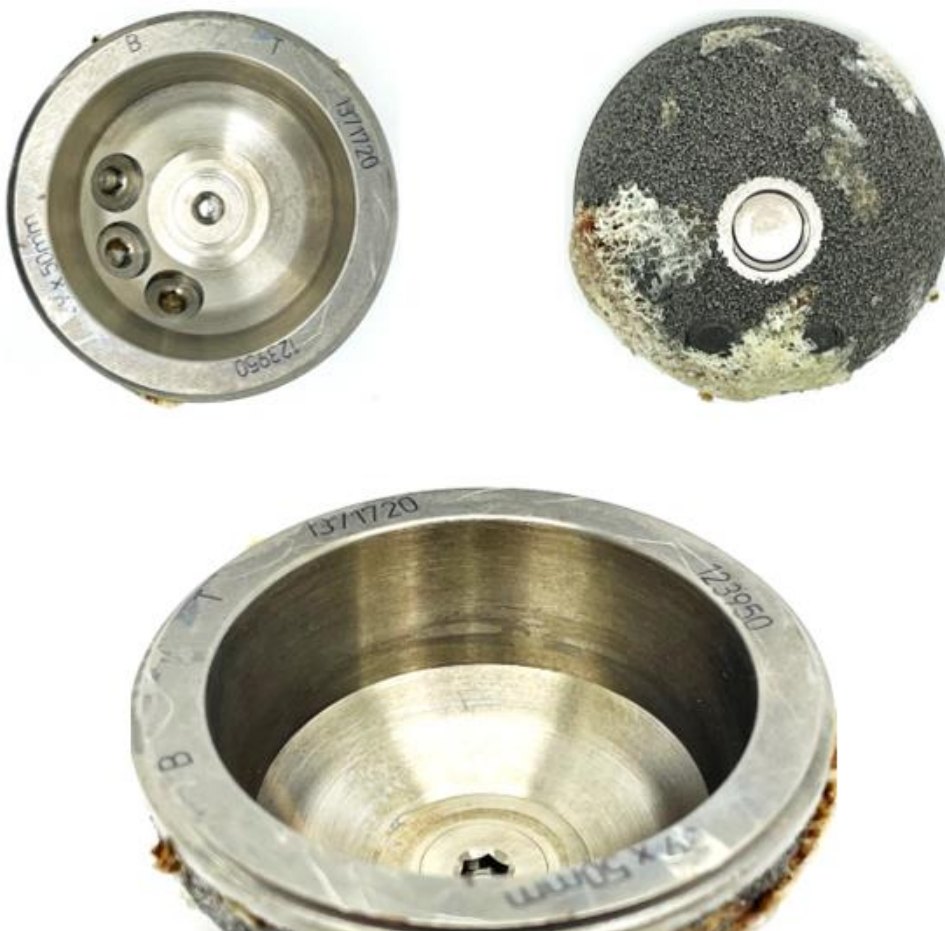
Acetabular shell (Ti alloy)

On receipt at ExplantLab, biological fluid/precipitate was present between the acetabular shell and liner. Additionally, there was surface discolouration on the inferior surface. These findings indicate fluid ingress between the shell and liner. There was limited bone growth on the posterior surface. Retrieval damage was identified on the rim.

The acetabular shell-liner interface did not appear to function optimally, with fluid ingress and an asymmetric pattern of metal transfer on the ceramic liner.

Metal release therefore from the posterior surface of the shell and potentially from the shell liner interface was the likely source of the “adverse reaction to particulate debris” described by the surgeon.

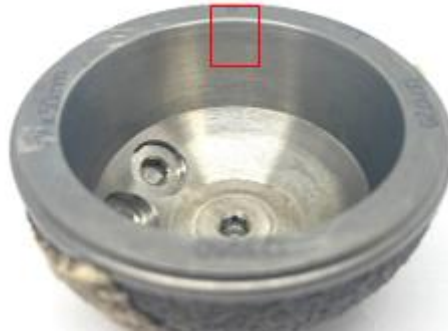
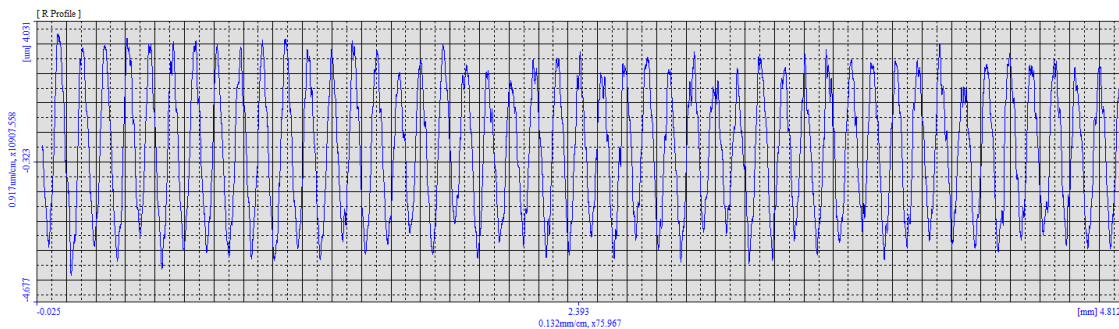
Surface roughness analysis

Surface profilometry was performed over the area shown by the red box in the image below.

Ra = 1.737 μm

Rpk = 0.254 μm

Rvk = 0.566 μm

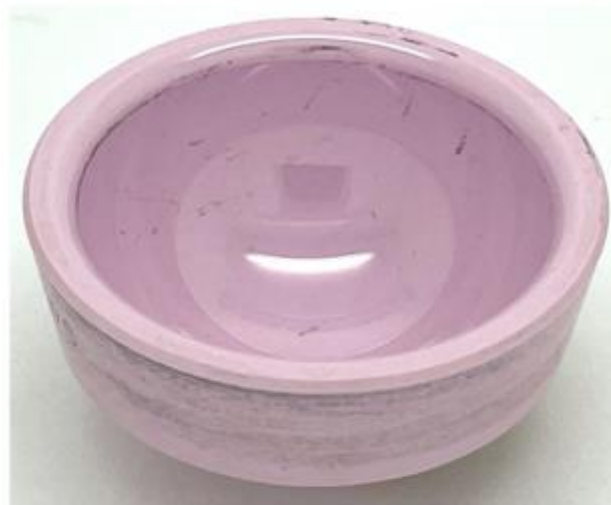
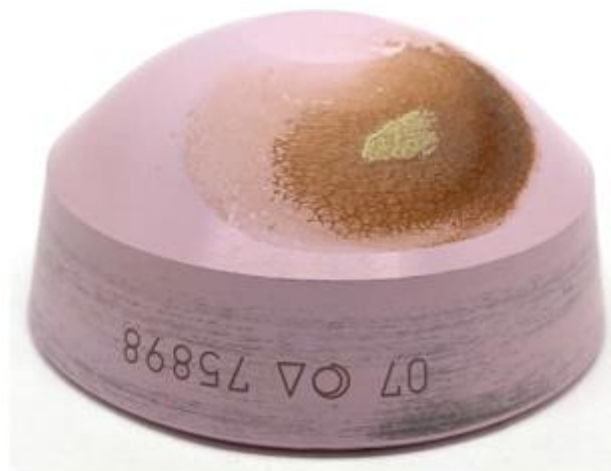
Acetabular Liner

There were isolated grey areas on the bearing surface. There was reddish-brown discolouration, indicating staining from a biological fluid, as well as grey discolouration on the posterior surface. There was asymmetric metal transfer on the outer taper, this was more pronounced than is normally found.

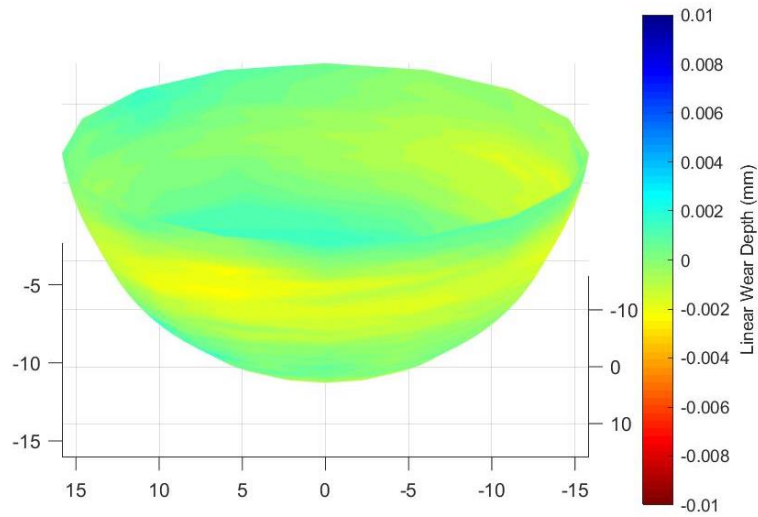
Coordinate Measuring Machine (CMM) analysis

Max Linear Wear (μm)	Volumetric Wear (mm^3)	Nominal Diameter (mm)
Acetabular Liner	4	0.75	32.0350

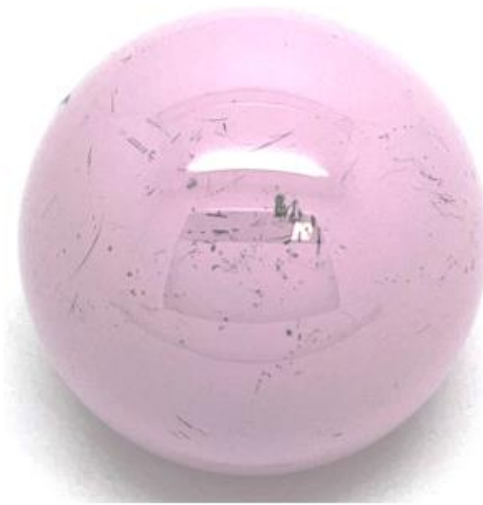
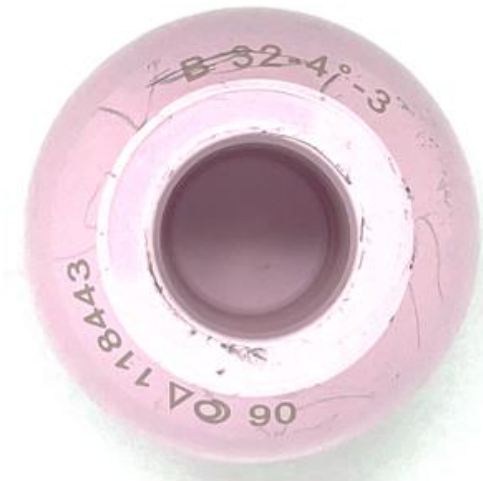
Femoral head

There were grey markings on the bearing surface – most likely due to the third body debris. Retrieval damage was identified on the bearing surface and at the base of the component.

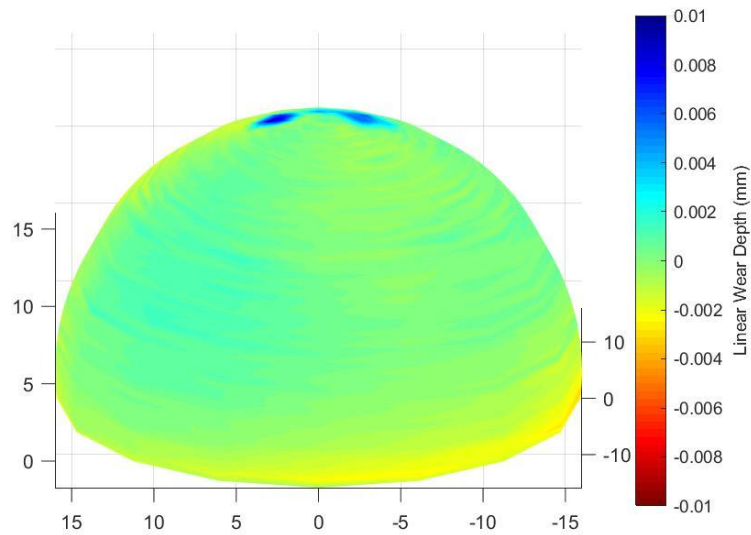
Coordinate Measuring Machine (CMM) analysis

Max Linear Wear (µm)	Volumetric Wear (mm³)	Nominal Diameter (mm)
Femoral Head	3	0.87	32.0262

The diametrical clearance was calculated to be 8.8 microns.

The diametrical clearance was abnormally low – **less than 9 microns** - resulting in increased friction at the bearing surfaces, with the development of component instability.

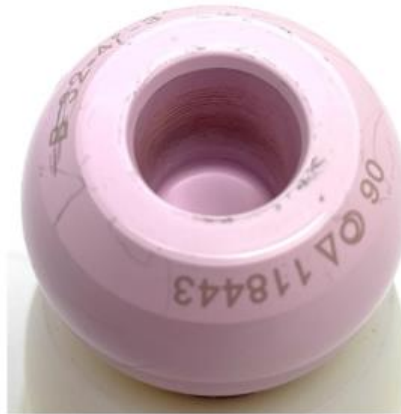
Female taper

There was reddish-brown discoloration on the surface. The imprinting of the male taper onto the female taper surface was clearly visible.

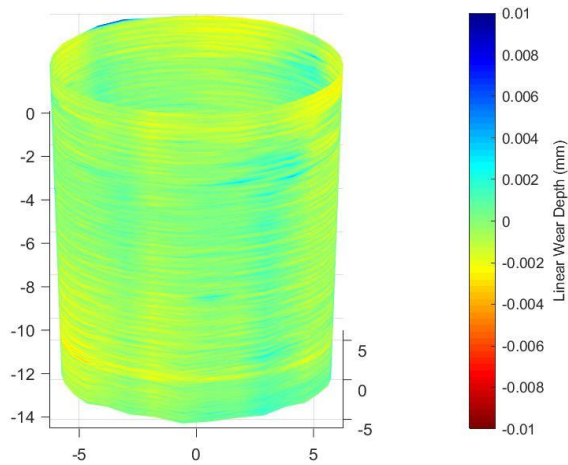
Coordinate Measuring Machine (CMM) analysis

Max Linear Wear (μm)	Volumetric Wear (mm^3)	Angle ($^\circ$)
Female Taper	4	0.22	4.080
