### **Implant details**

Reason for revision as listed by the surgeon: Dislocation/Subluxation, and Wear of Acetabular Component

Explanted prosthesis: 28 mm (+5 offset) DePuy MoP THR

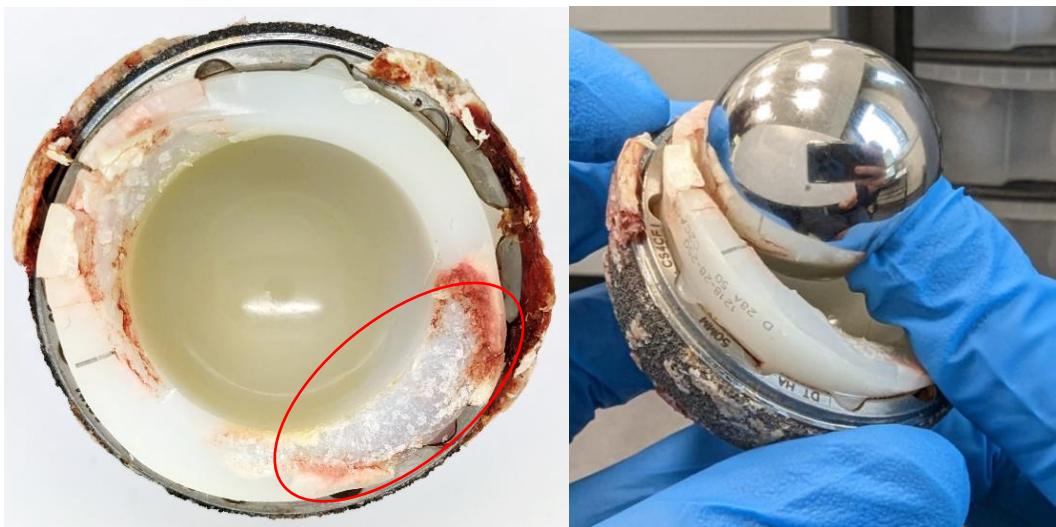
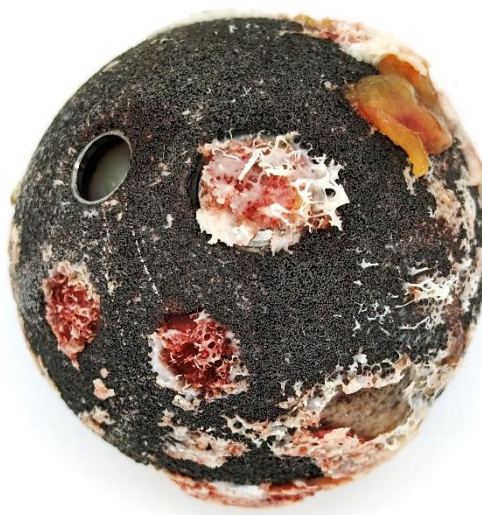
There was damage to the rim of the polyethylene liner consistent with femoroacetabular impingement, as shown by the red ellipse in the macroscopic image below. There was also damage on the rim directly opposite the site of impingement, most likely due to the head subluxation consistent with the reason for revision as listed by the surgeon. There was yellow discoloration on the bearing surface. There was significant bone growth on the posterior surface. Retrieval damage was identified on the rim.

There was severe damage on the rim of the liner due to impingement and instability of the hip.

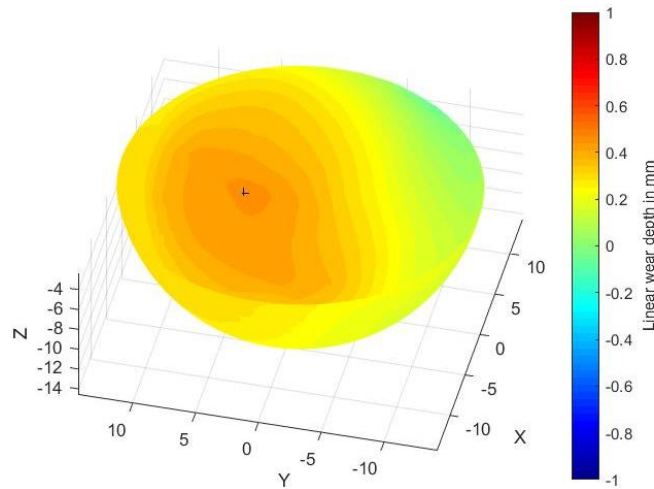
**Coordinate Measuring Machine (CMM) analysis**

| | <b>Max Linear<br/>Wear (<math>\mu\text{m}</math>)</b> | <b>Volumetric<br/>Wear (<math>\text{mm}^3</math>)</b> | <b>Nominal<br/>Diameter (mm)</b> |
|---|---|---|---|
| <b>Acetabular<br/>Liner</b> | 451 | 285.52 | 28.5000* |

**\*estimated diameter; see comments in summary**

The volumetric wear rate of the acetabular liner was approximately 20 mm<sup>3</sup>/year. Due to liner deformation caused by impingement/subluxation, the unworn geometry of the sphere could not be accurately reconstructed, and the wear rate should be interpreted as an estimate only.

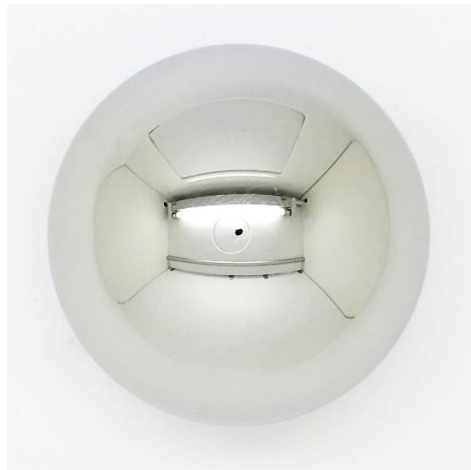
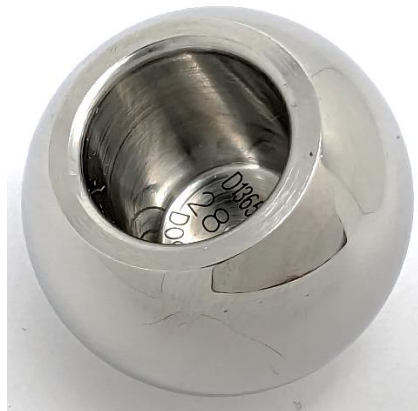
**Femoral head**

There were no clinically relevant abnormalities identified on macroscopic inspection. There was retrieval damage on the bearing surface.

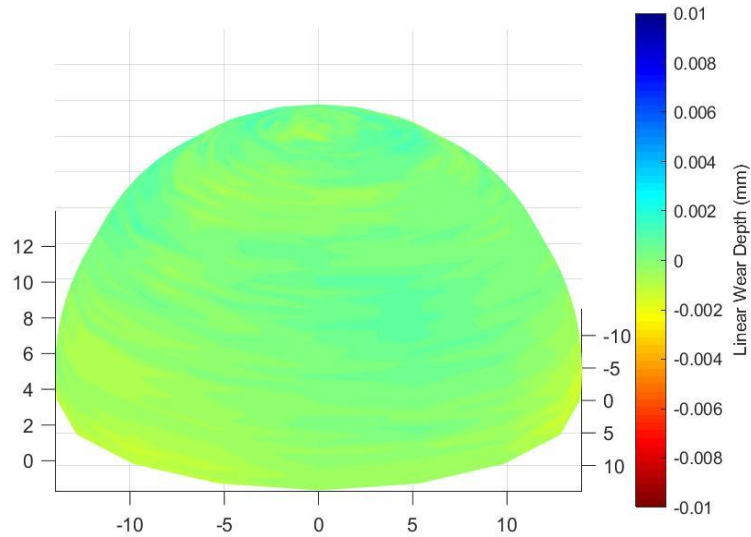
**Coordinate Measuring Machine (CMM) analysis**

| | <b>Max Linear<br/>Wear (μm)</b> | <b>Volumetric<br/>Wear (mm<sup>3</sup>)</b> | <b>Nominal<br/>Diameter (mm)</b> |
|---|---|---|---|
| <b>Femoral<br/>Head</b> | 2 | 0.21 | 27.9578 |

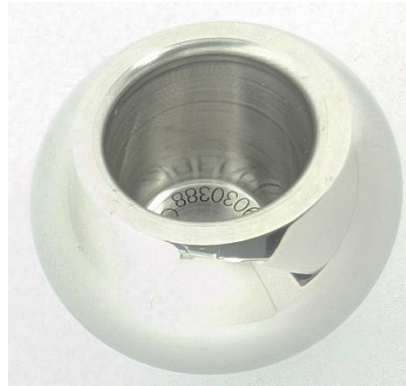
**Female taper**

There were no clinically relevant abnormalities identified on macroscopic inspection.

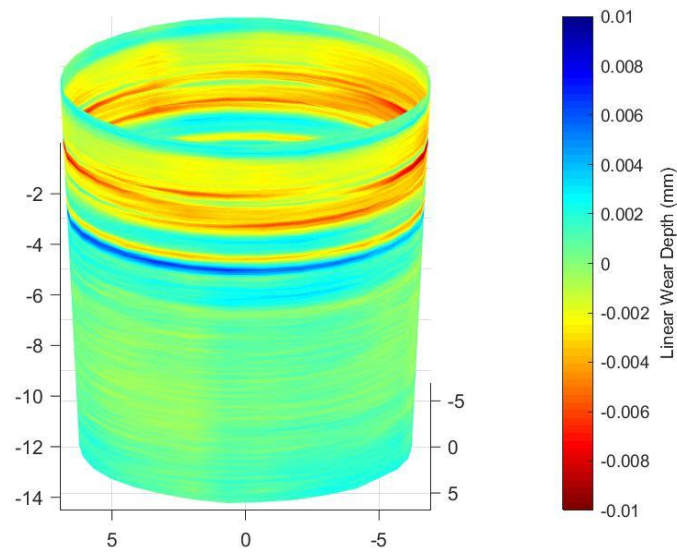
**Coordinate Measuring Machine (CMM) analysis**

| | <b>Max Linear Wear (<math>\mu\text{m}</math>)</b> | <b>Volumetric Wear (<math>\text{mm}^3</math>)</b> | <b>Angle (<math>^\circ</math>)</b> |
|---|---|---|---|
| <b>Female Taper</b> | 9 | 0.38 | 5.660 |

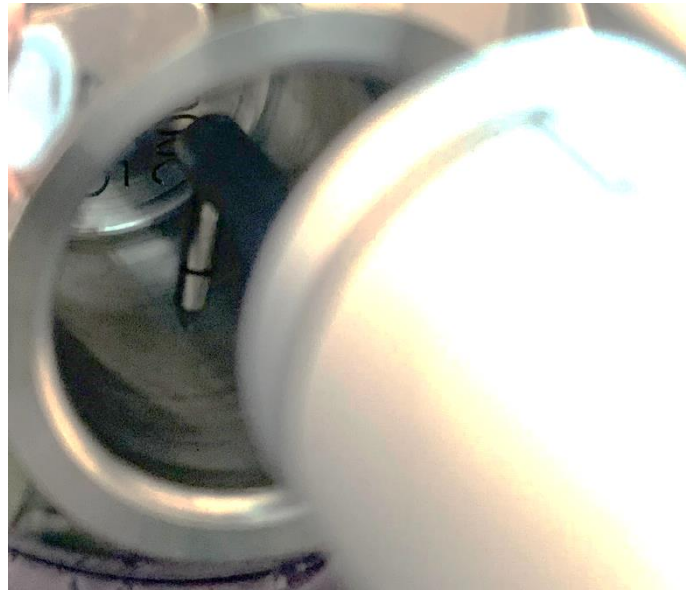
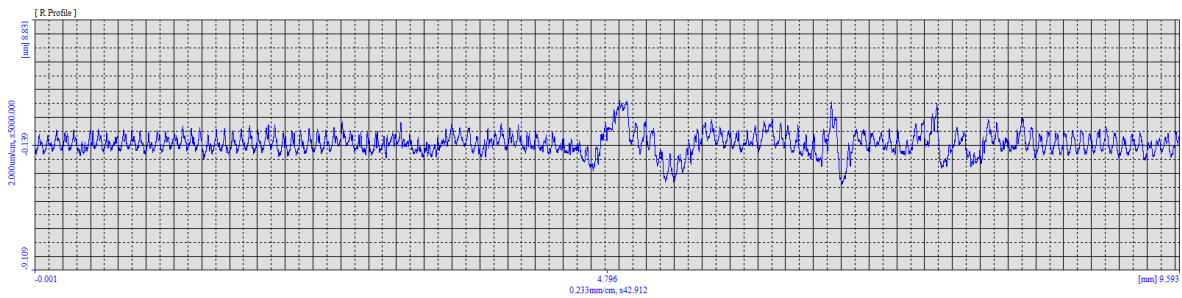
### Surface roughness analysis

There were no clinically relevant abnormalities identified on profilometry.

$R_a = 0.566 \mu\text{m}$ ,  $R_pK = 0.999 \mu\text{m}$ , and  $R_vK = 1.189 \mu\text{m}$
