Implant details

Reason for revision as listed by the surgeon: Peri-Prosthetic Fracture

Explanted prosthesis: PS DePuy PFC (DΣGVF) TKR

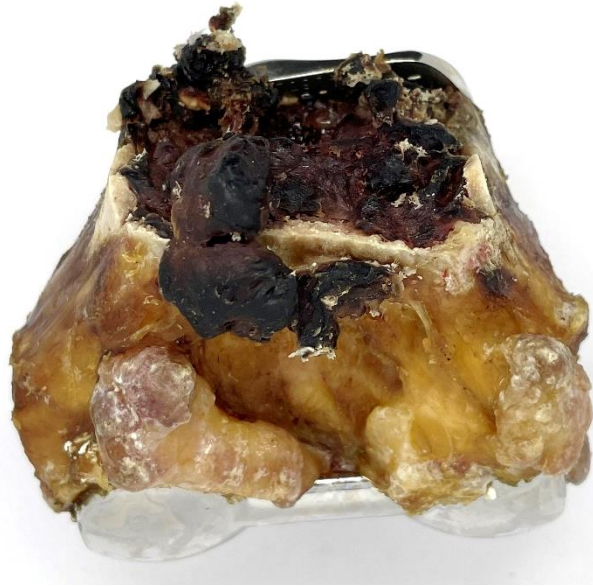
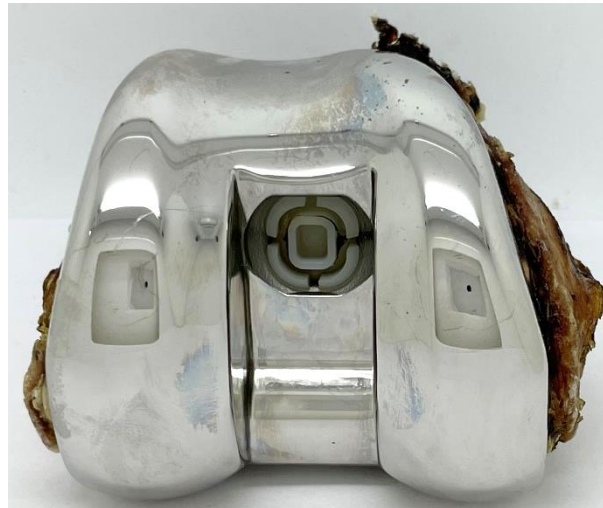
Femoral component (CoCr alloy)

The femoral cement mantle was stable. There were no clinically relevant abnormalities identified on macroscopic inspection of the bearing surface.

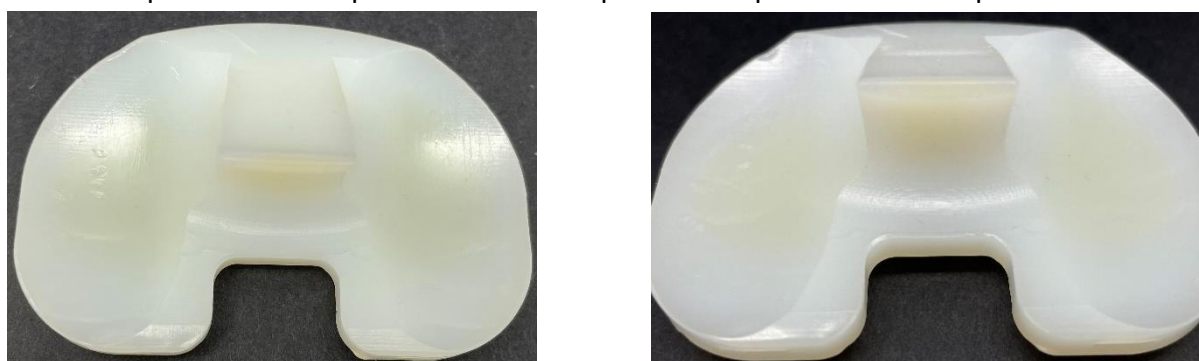
Bearing surface

There was widespread damage, including striations, pitting and scratching, on the medial and lateral condyles. There was yellow discolouration of the central condylar regions and the posterior aspect of the tibial post. Retrieval damage was identified on the bearing surface, anterior aspect of the component and on the posterior aspect of the tibial post.

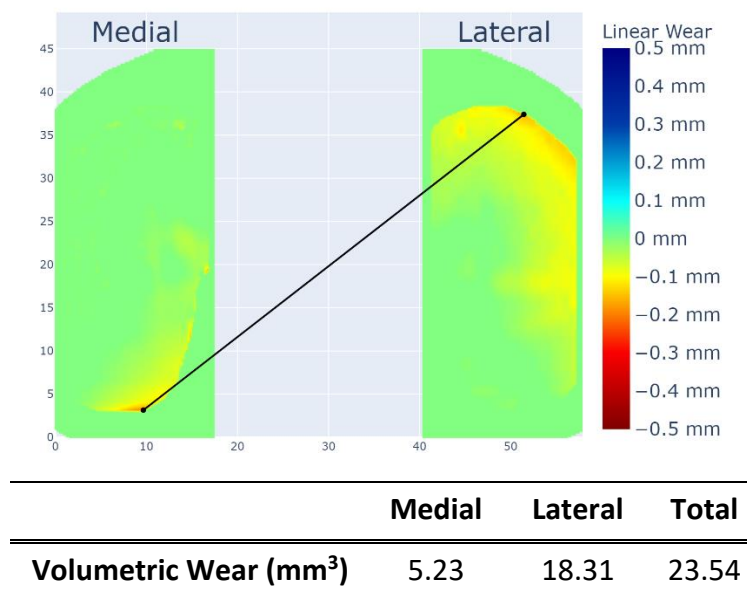
Coordinate Measuring Machine (CMM) analysis

The angle between the centre of the medial and lateral wear scars was 39° (39° internal rotation).

The volumetric wear rate for the polyethylene insert could not be calculated as the implantation date was unknown. The median volumetric wear rate of the polyethylene inserts of contemporary TKRs received at ExplantLab is 9 mm³/year.

Low total volumetric wear from the bearing surface.

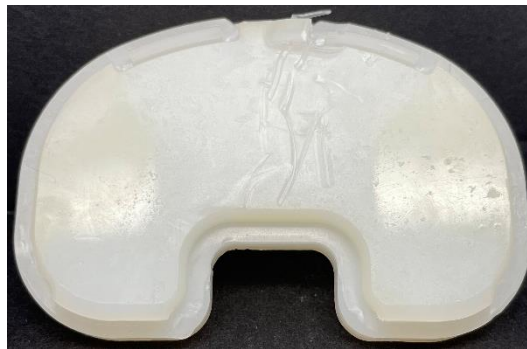
Backside surface

There was widespread pitting and yellow discolouration identified. Retrieval damage was identified on the insert locking mechanism.

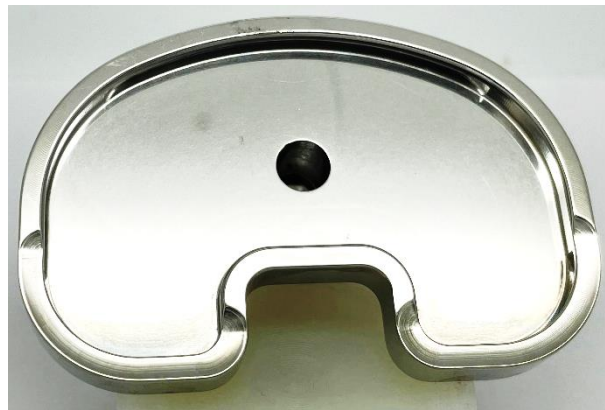
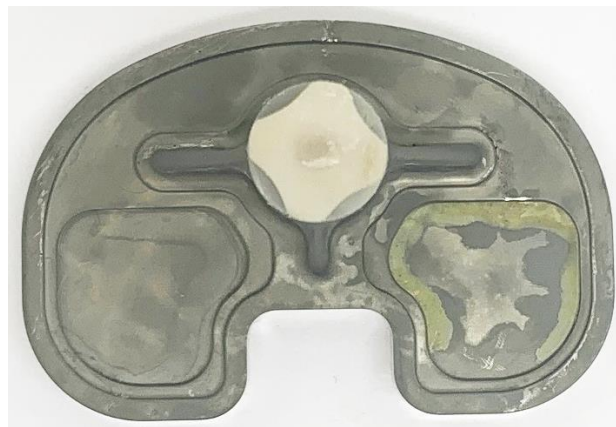
Tibial tray (CoCr alloy)

There were no clinically relevant abnormalities identified on macroscopic inspection of the superior surface. There was minimal retained cement on the inferior surface but no surface changes consistent with tray instability. Retrieval damage was identified on the superior and inferior surfaces.
